INCIDENT ALERT

Contractor Severs Fingers on Conveyor Belt

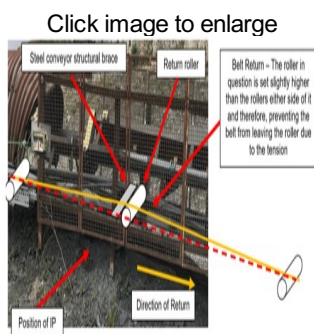
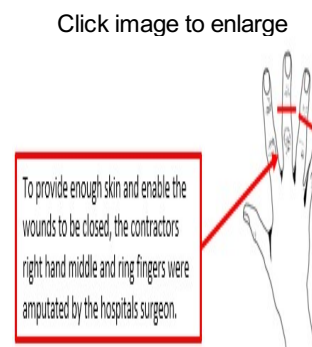
ACCIDENT / INCIDENT IMAGES

One of the contractors notice a flapper (small strip of belting) hanging from the edge of the belt as it was running. The contractor knelt down and reached underneath the guard grabbing the flapper, believing that it would snap off. Instead it pulled his hand over a return roller with the belt trapping it. As he pulled his hand back the 3rd & 4th fingers of his right hand were degloved to the first knuckle.

- Original task was completed according to procedures including isolation, Risk Assessment and Method Statement and Worksafe.
- The Safety Inspections, VFL's and training reports were all up to date.
- Emergency response plan was followed.
- The roller was set slightly higher than the two either side of it, causing additional tension on the belt so it could not lift from the roller.
- Due to the above, to meet British Standards, the guard should have been slightly larger; however this would not have prevented the injury.
- The contractor had worked on the site for 10 years.

- Guarding fully extended to the ground.
- Follow site rules and never attempt to touch a piece of moving equipment.

- Are return rollers inspected, checking that the belt can easily yield 50mm from the roller?
- Where the belt cannot yield 50mm from the roller, is there sufficient guarding in place to ensure that the trapping point cannot be reached?
- Is there a Safe System of Work for conveyor belt maintenance and removal of flappers and are they communicated to the workforce?
- Have employees received the STOP-THINK-ACT training helping them to identify hazards, and keep out of the line of fire?
